5RD-T1-ABS-BC

SECTION A-A
BASE COVER CROSS SECTION DETAIL VIEW

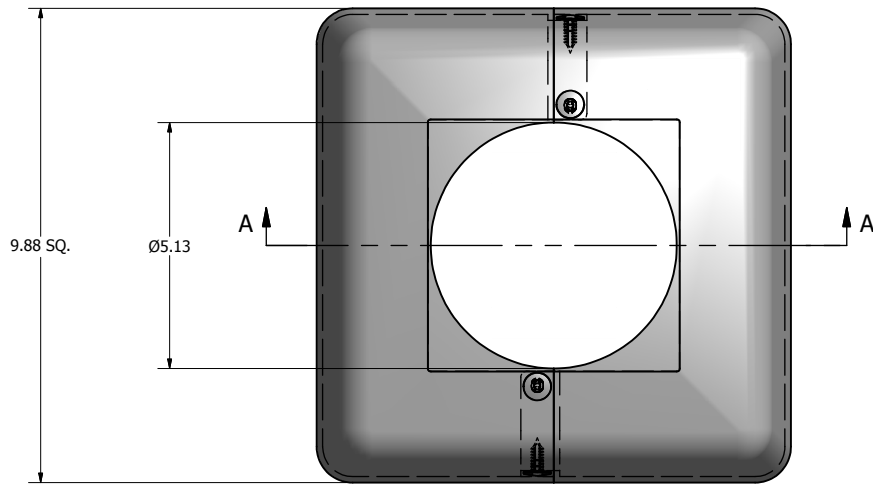
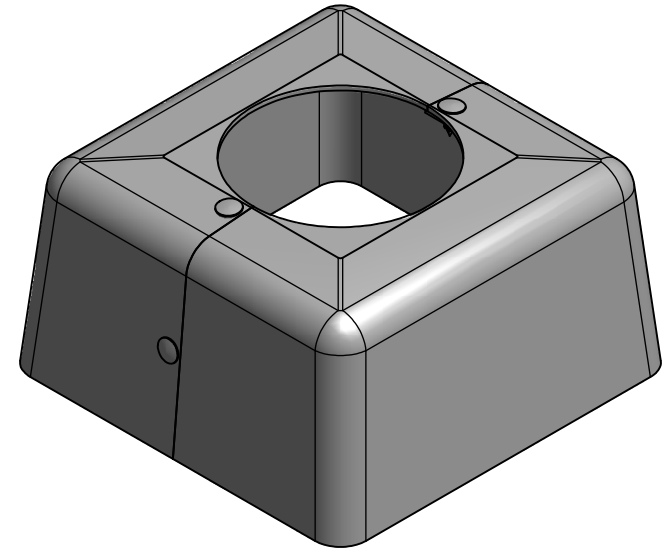
BASE COVER FASTENED
TOGETHER WITH 4
PUSH PINS.
